Renewable Energy Systems Limited

Mynydd Maen Wind Farm

Phase 2 Site Investigation - Coal Mining Risk Assessment

315198-R02 (02)

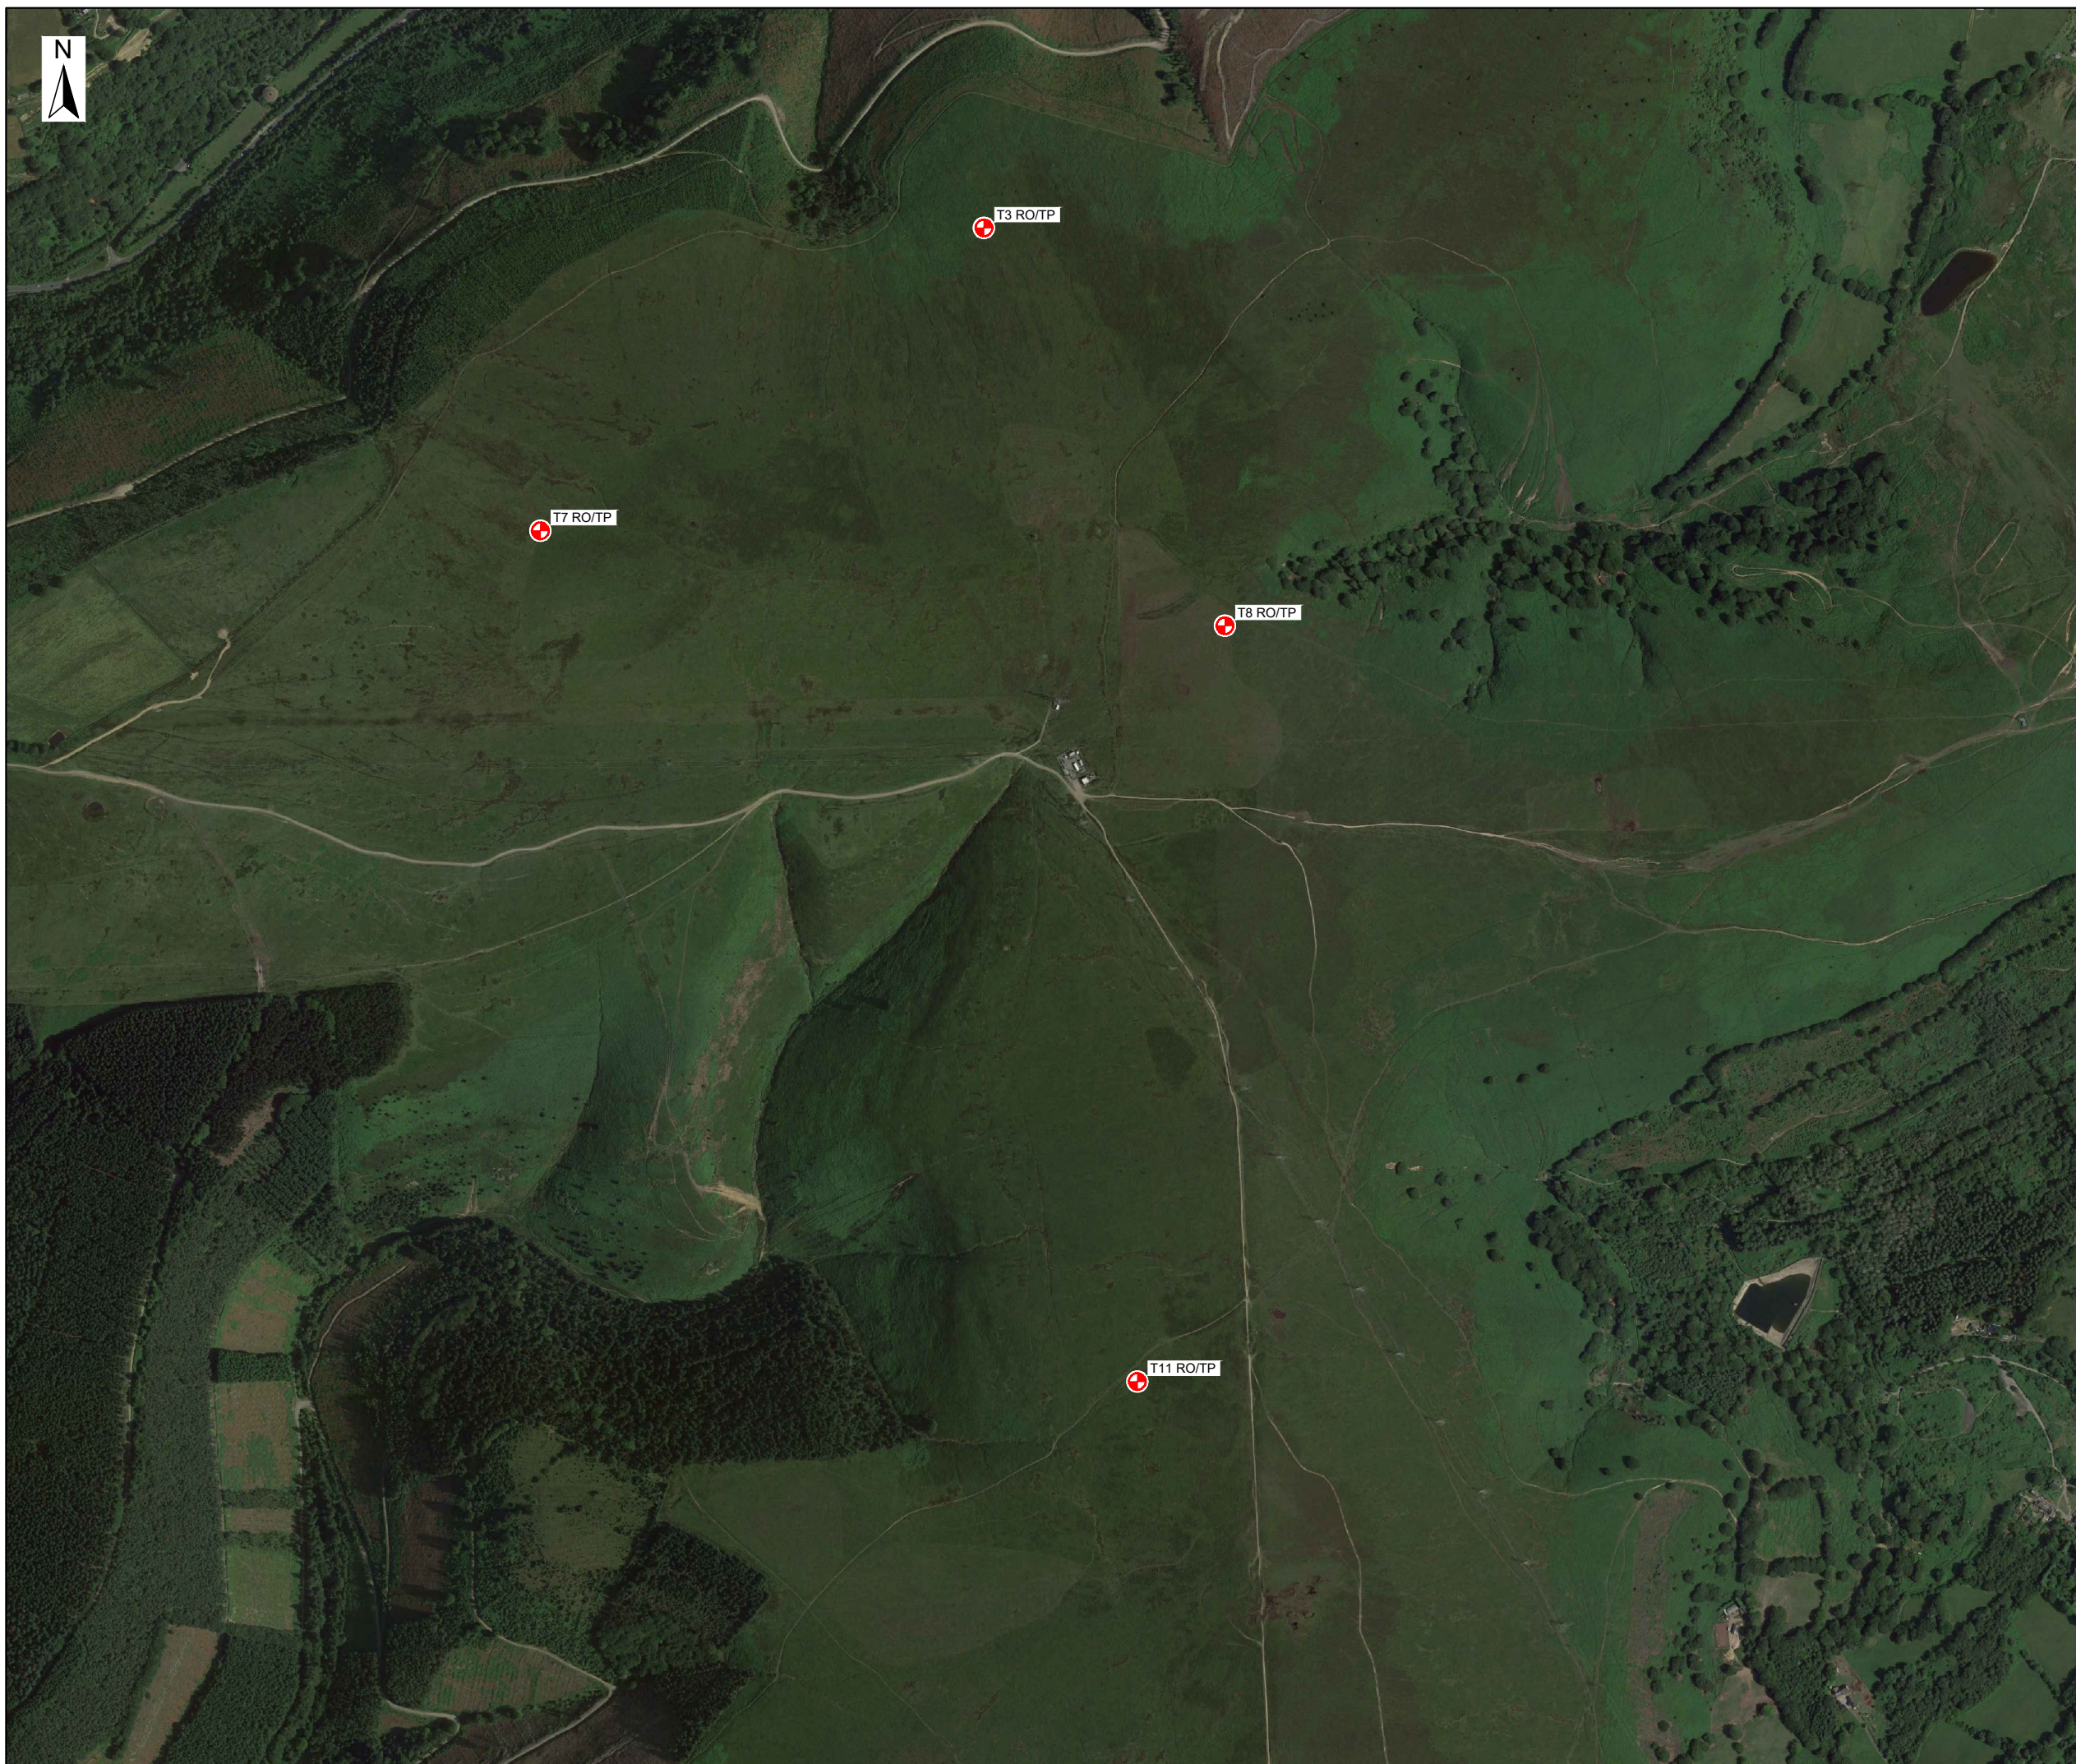
FIGURE 3 EXPLORATORY HOLE LOCATION PLAN

Details of the investigation locations and rationale are presented in Table 4. Machine excavated trial pits were dug at each of the four proposed turbine locations (T3, T7, T8 and T11) to a maximum depth of 2.50m bgl before being backfilled with arisings. Four rotary open holes were drilled at each of the four turbine locations to a maximum depth of 20m bgl before being backfilled with bentonite. An exploratory hole location plan is shown on **Figure 3**.
