Watercourse Survey

Mynydd Maen Wind Farm

Ref 04412-6373697

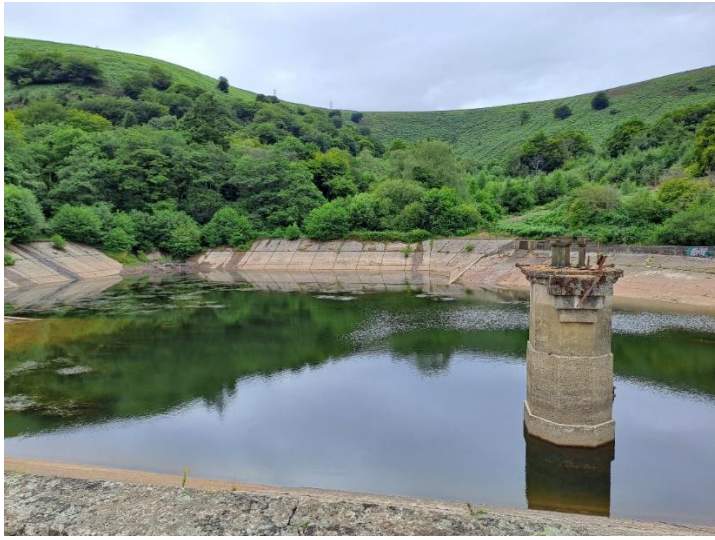
<p data-bbox="156 904 225 936">2.3.1</p>	<p data-bbox="903 360 1382 434">Reservoir noted as disused on ordnance survey maps.</p> <p data-bbox="903 468 1329 499">Concrete lined manmade reservoir.</p> <p data-bbox="903 535 1297 566">Inlet channel bypasses reservoir.</p> <p data-bbox="903 602 1353 633">Water level approximately 1 m deep.</p> <p data-bbox="903 669 1398 743">Water body appeared to be stagnant and visual evidence of poor quality.</p>
<p data-bbox="156 956 496 987">Blaen Bran bypass channel</p>

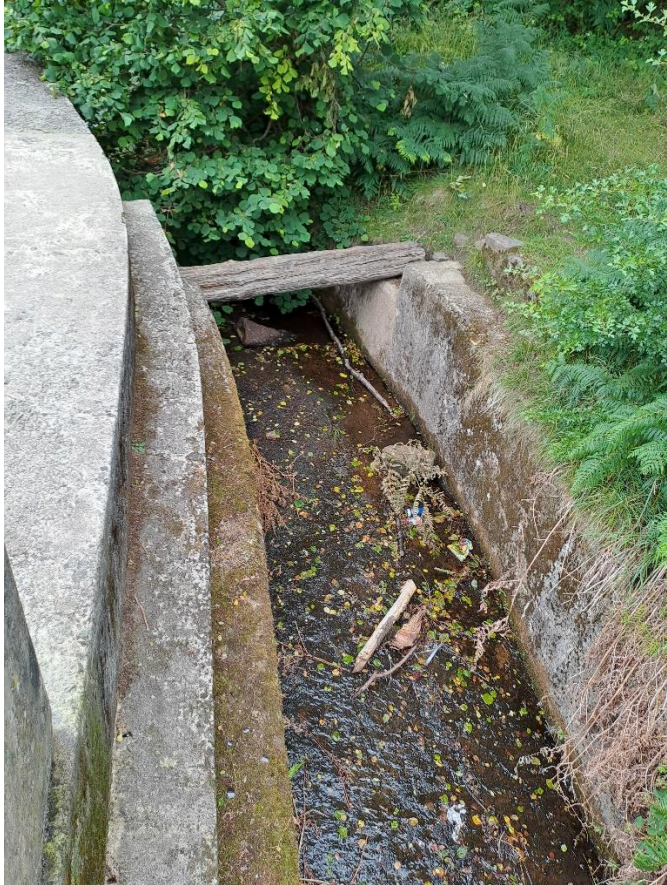
<p data-bbox="156 1928 225 1960">2.3.2</p>	<p data-bbox="903 1039 1437 1151">Concrete channel on northern edge running west to east, approximately 1 m wide. Channel bypasses reservoir in low flows.</p> <p data-bbox="903 1184 1278 1216">Minimal flow at time of survey.</p>

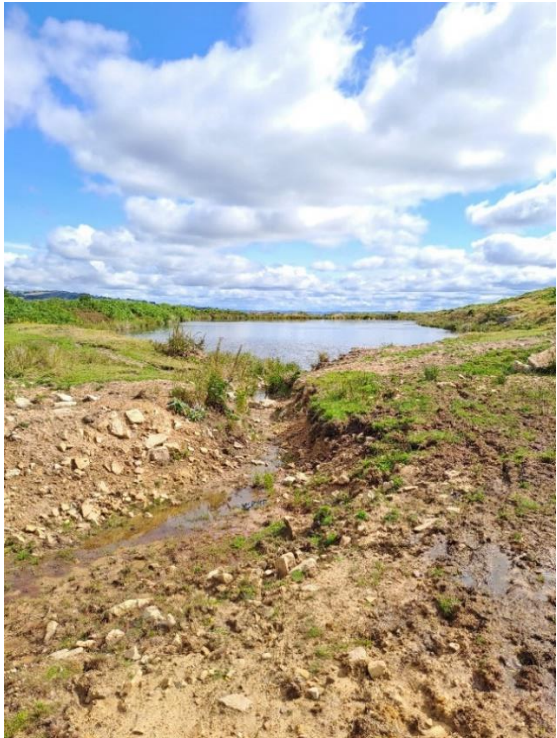
<p data-bbox="156 1106 225 1137">2.4.1</p>	<p data-bbox="810 360 1302 392">Inlet channel bypasses pond in low flow.</p> <p data-bbox="810 427 1198 459">Standing water in inlet channel.</p> <p data-bbox="810 495 1129 526">Evidence of scour at inlet.</p>
<p data-bbox="156 1158 608 1189">Cwm Lickey Pond feeder drain no. 1</p>	
  <p data-bbox="156 1975 225 2007">2.4.2</p>	<p data-bbox="810 1234 1177 1265">Dry channel at time of survey.</p>

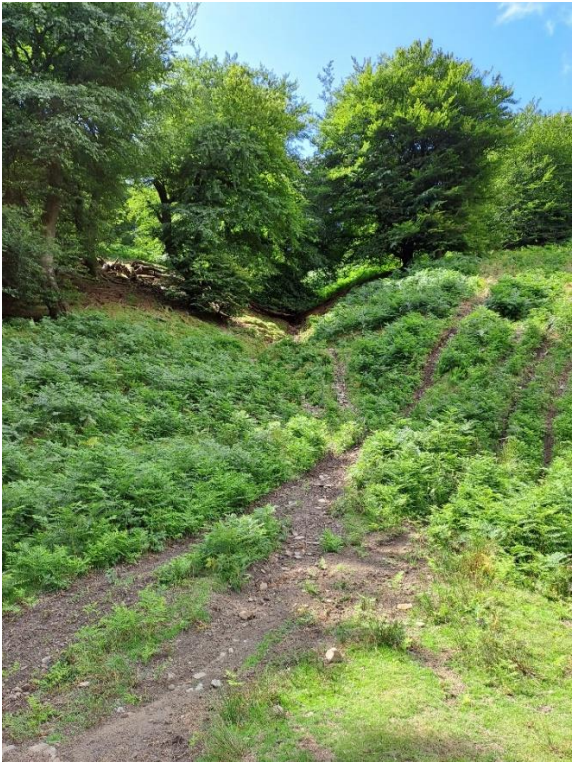
<p data-bbox="158 1048 225 1081">2.4.3</p>	<p data-bbox="810 280 1181 313">Dry channel at time of survey.</p>
<p data-bbox="158 1097 611 1131">Cwm Lickey Pond feeder drain no.3</p>

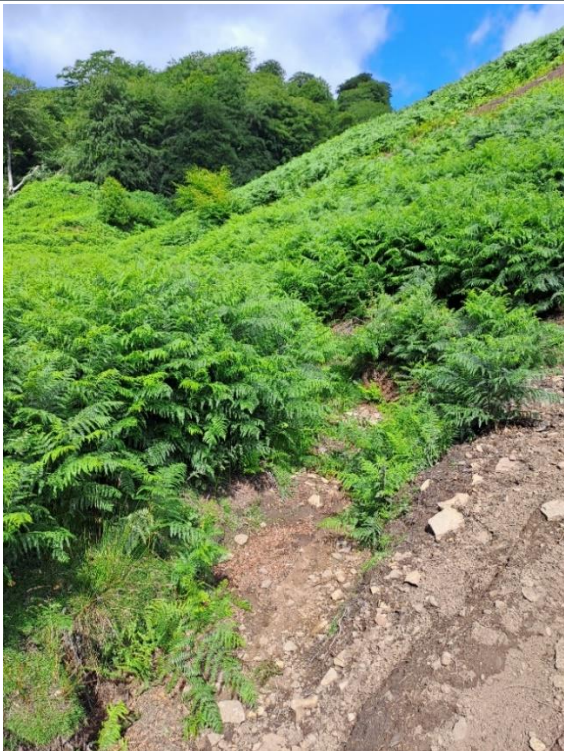
<p data-bbox="158 1937 225 1971">2.4.4</p>	<p data-bbox="810 1180 1181 1214">Dry channel at time of survey.</p>

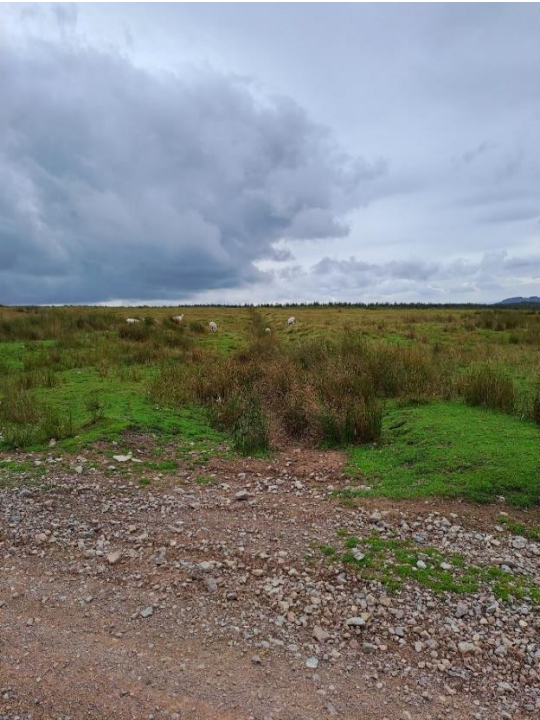
<p data-bbox="156 1088 225 1122">2.6.1</p>	<p data-bbox="810 360 1169 394">Dry / poorly defined channel.</p>

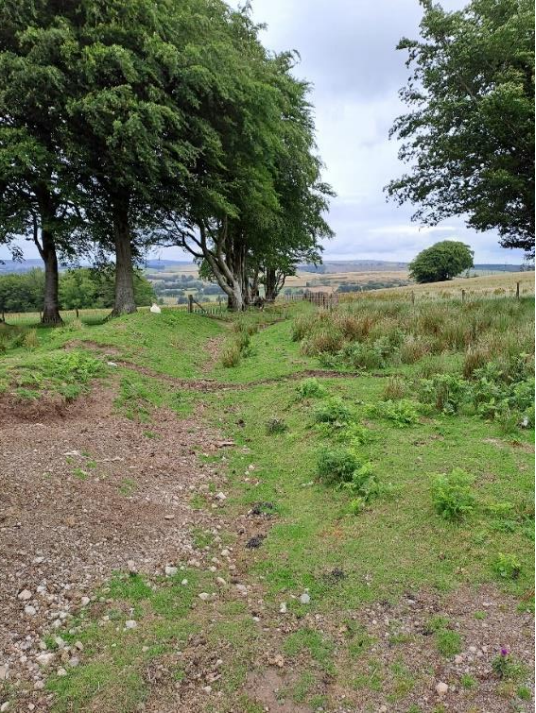
<p data-bbox="156 1944 225 1977">2.6.2</p>	<p data-bbox="810 1223 1169 1256">Dry / poorly defined channel.</p>
