# Mynydd Maen Wind Farm

Phase 2 Site Investigation - Coal Mining Risk Assessment

315198-R02 (03)

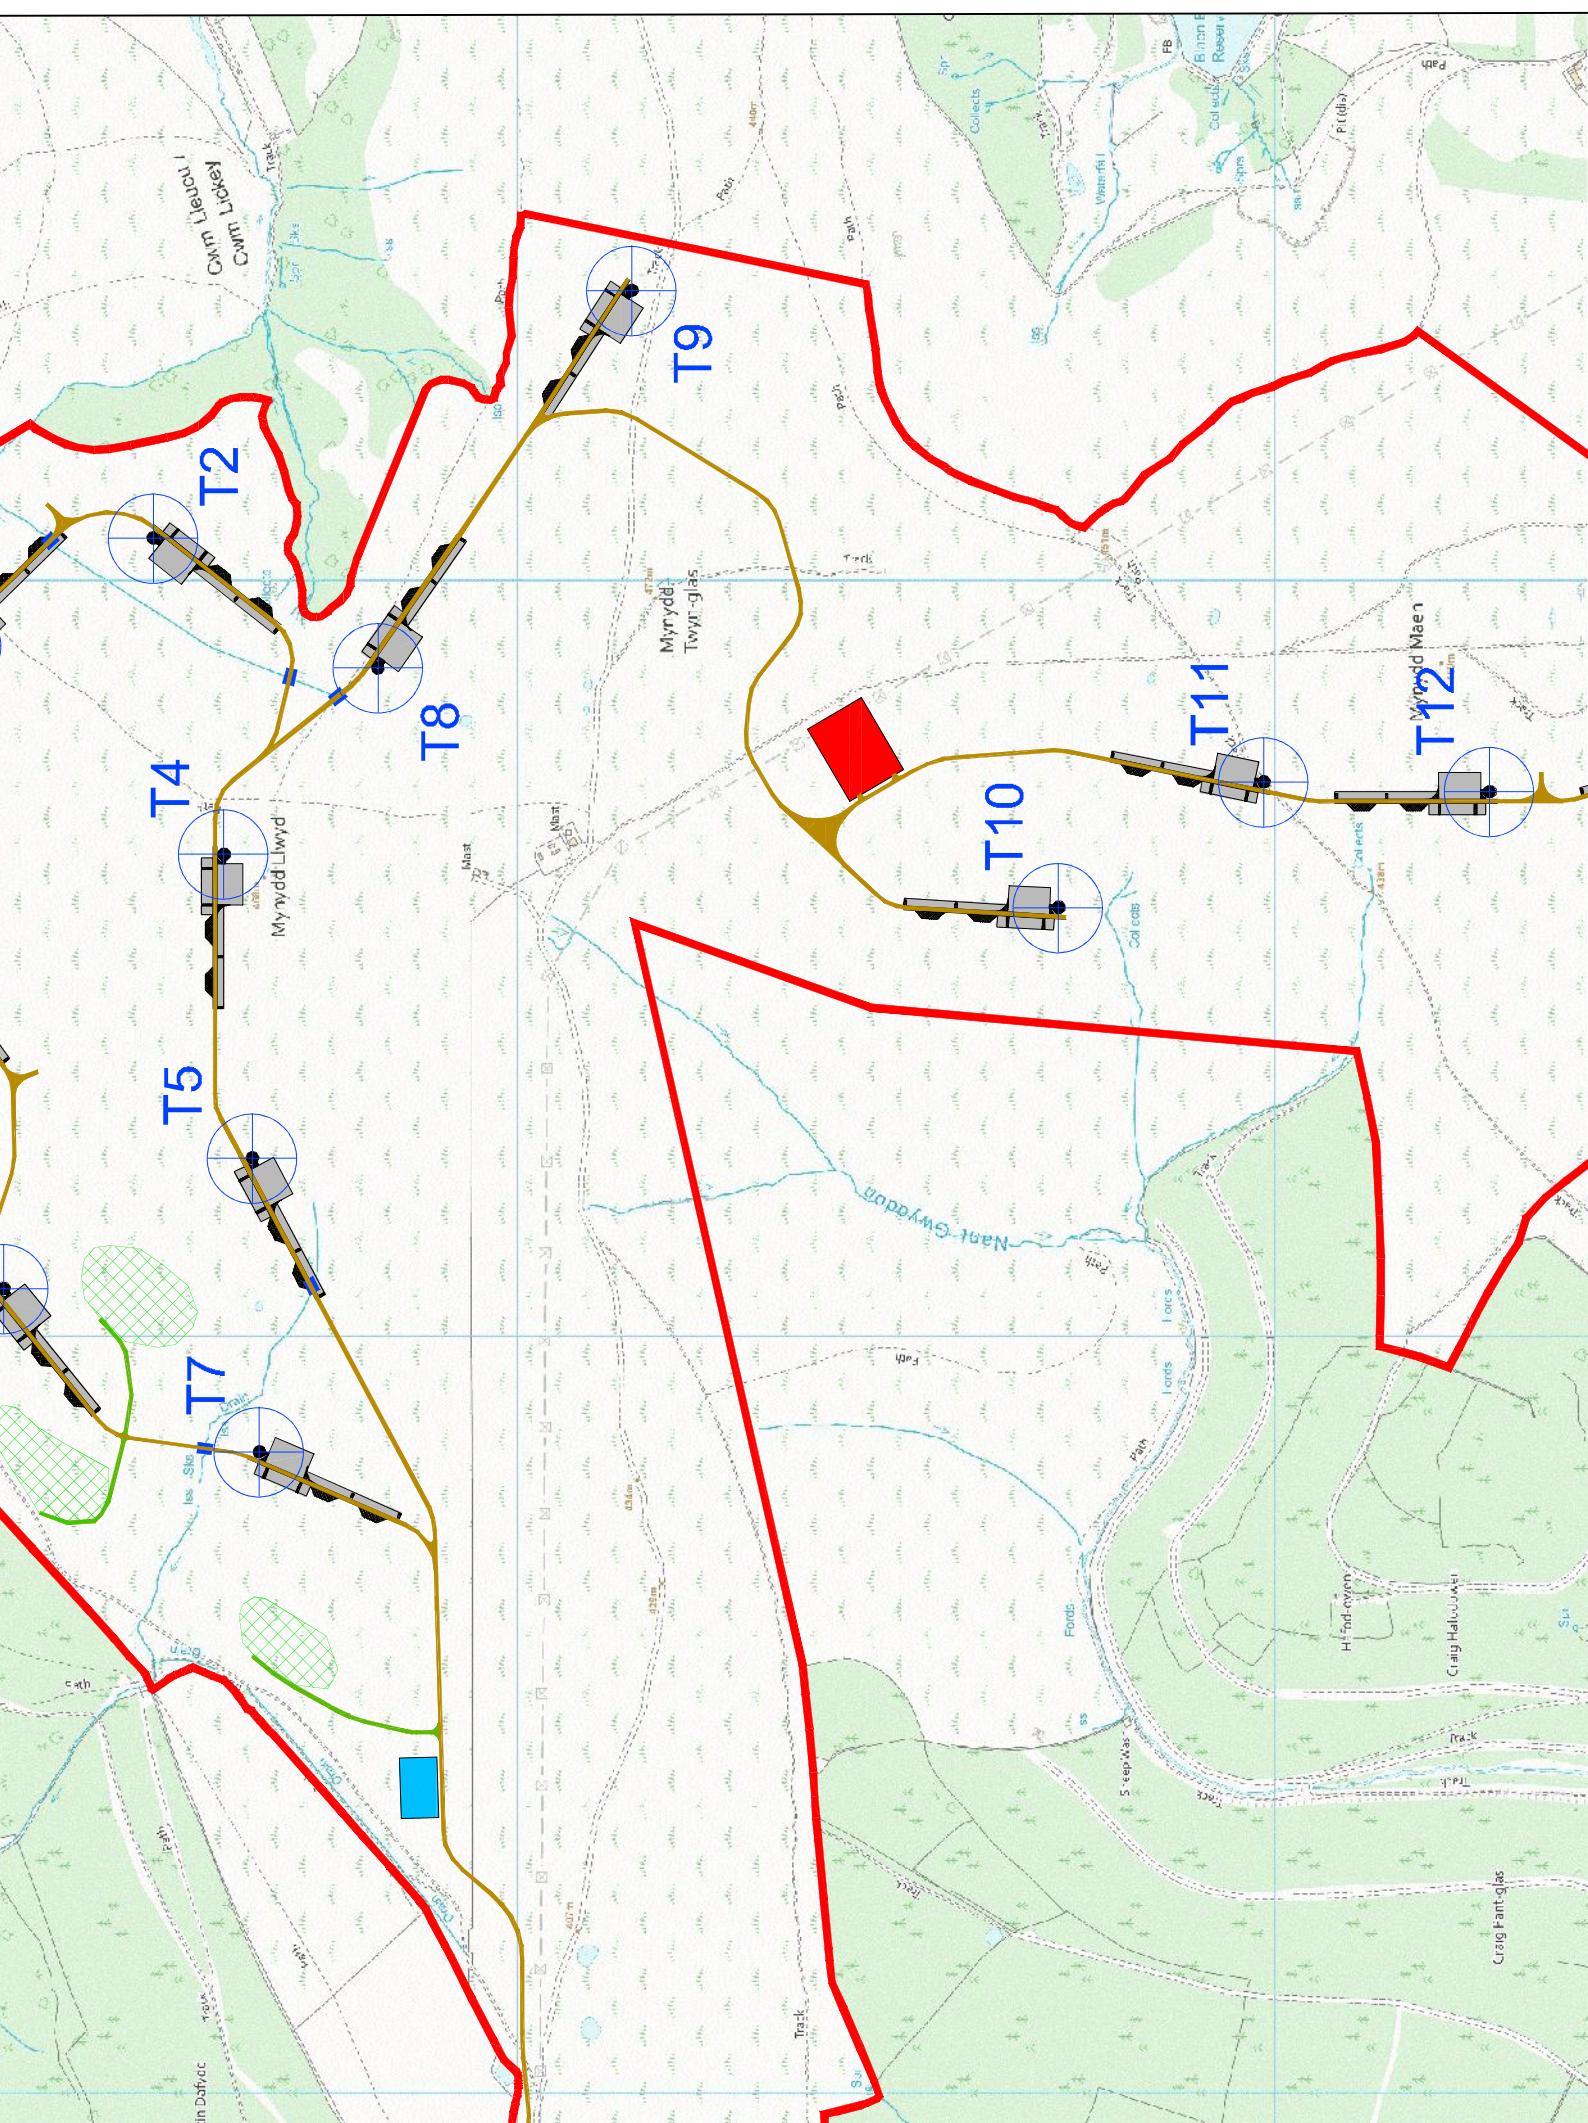
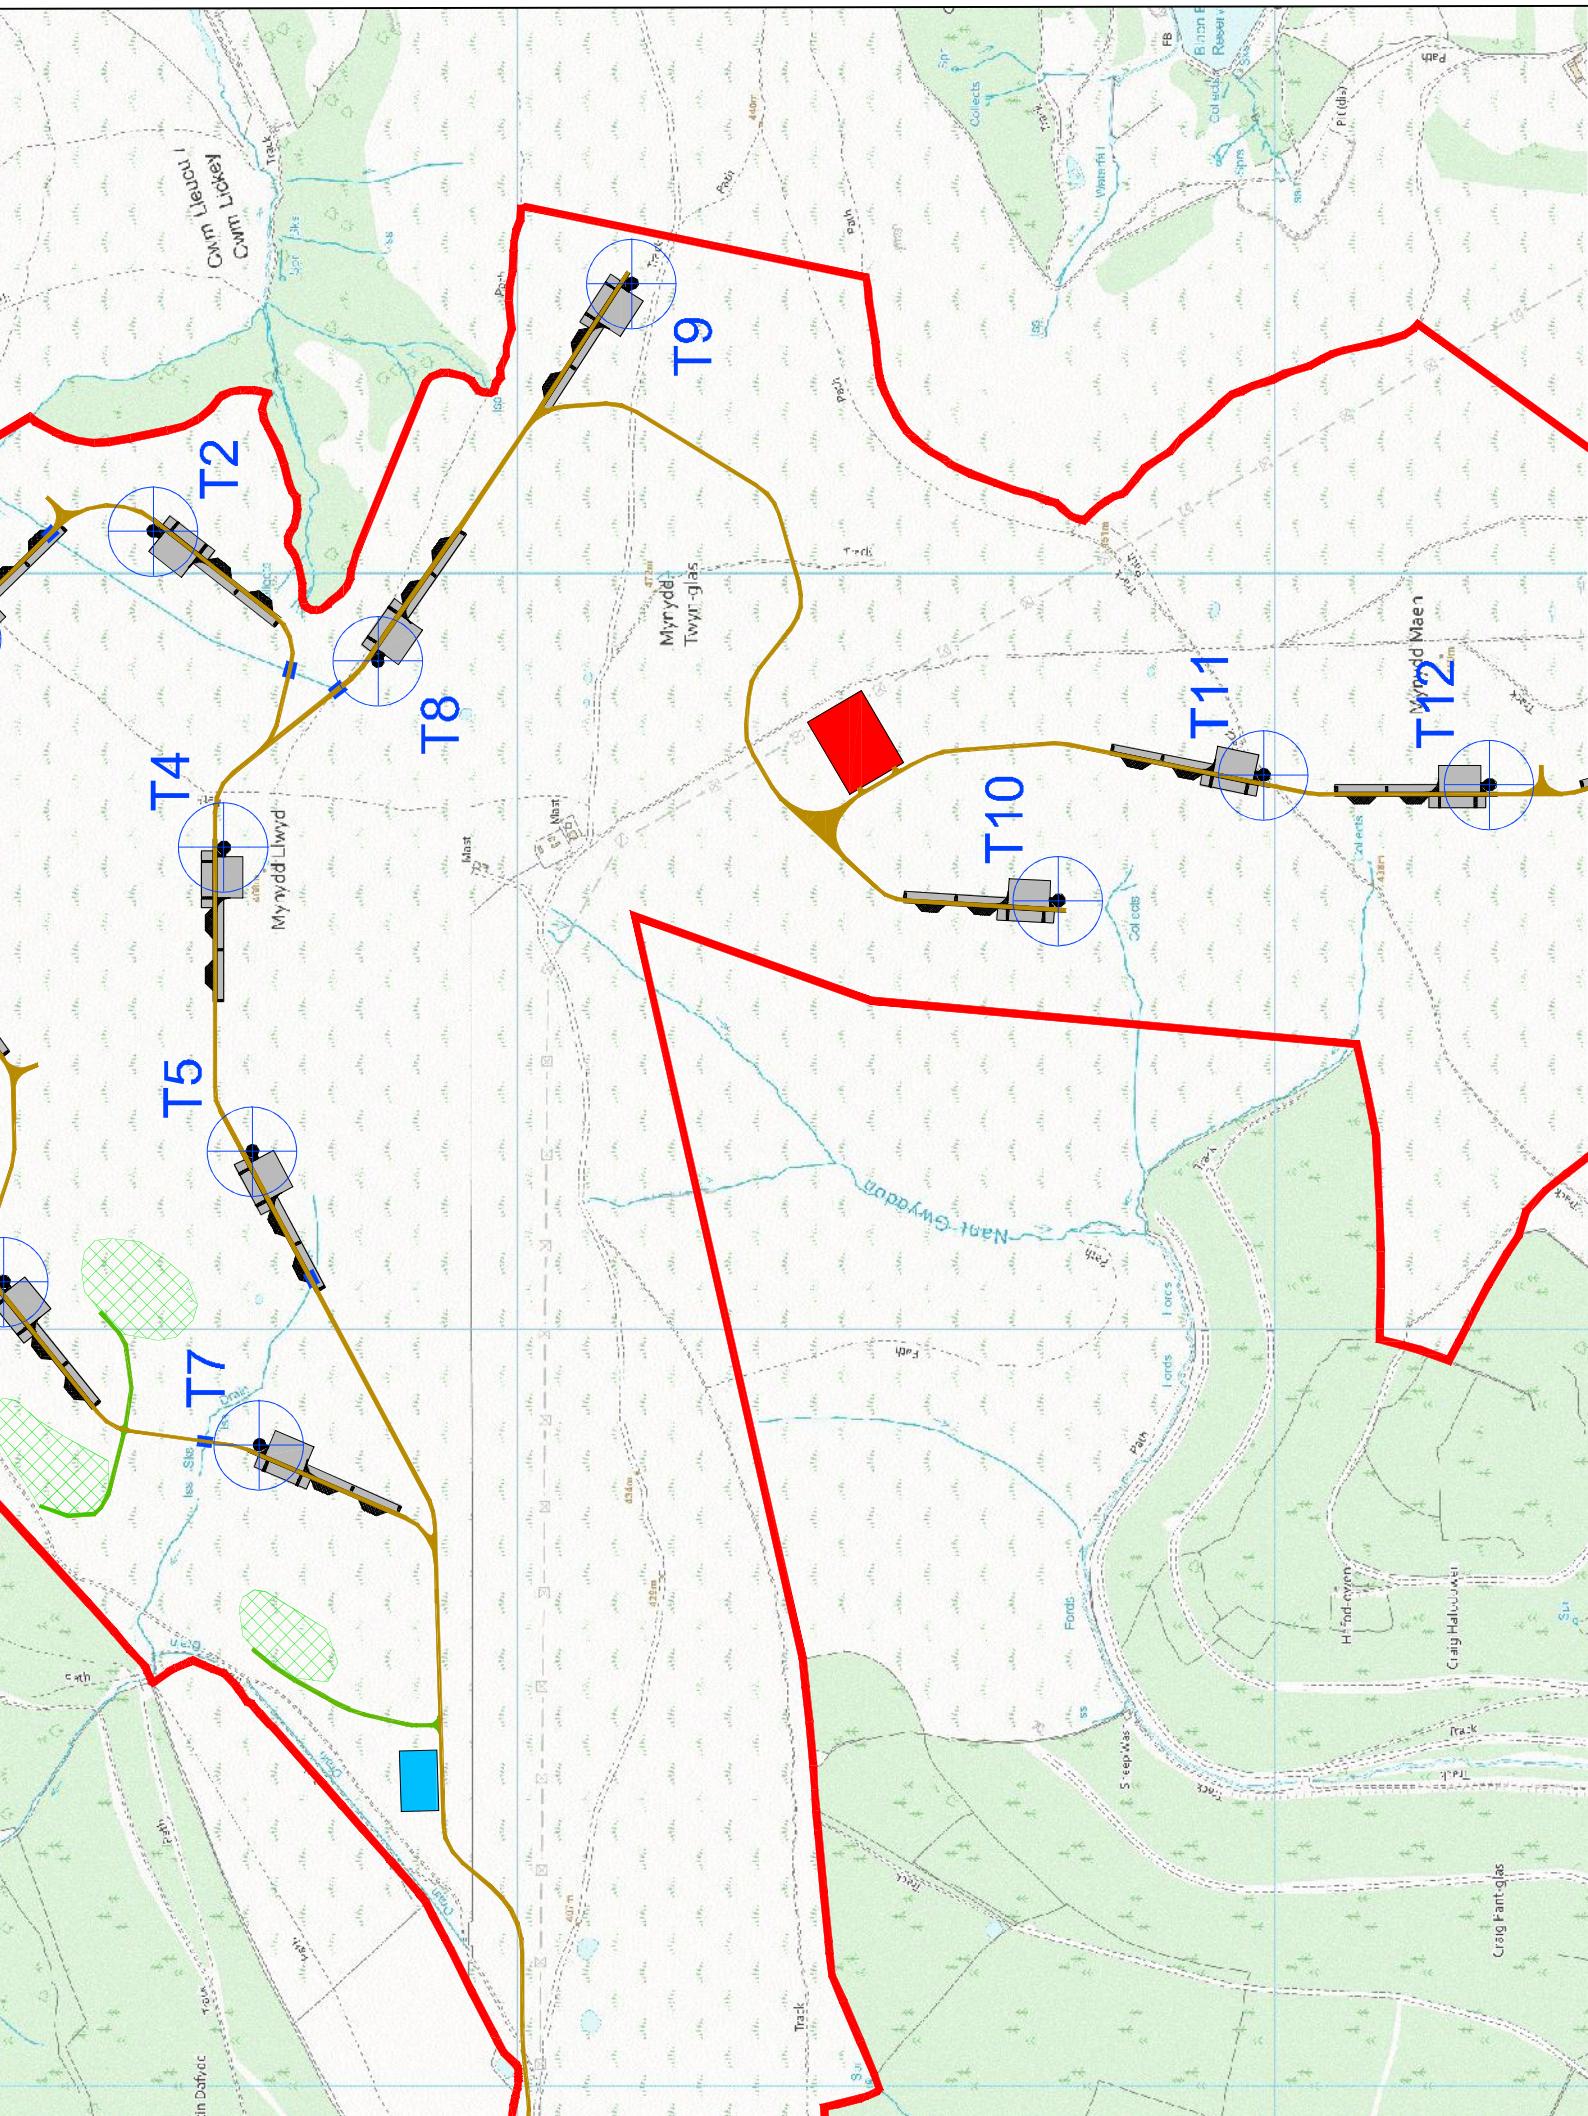
## FIGURE 2 SITE LAYOUT PLAN

The site boundary and current layout are presented in **Figure 2**.

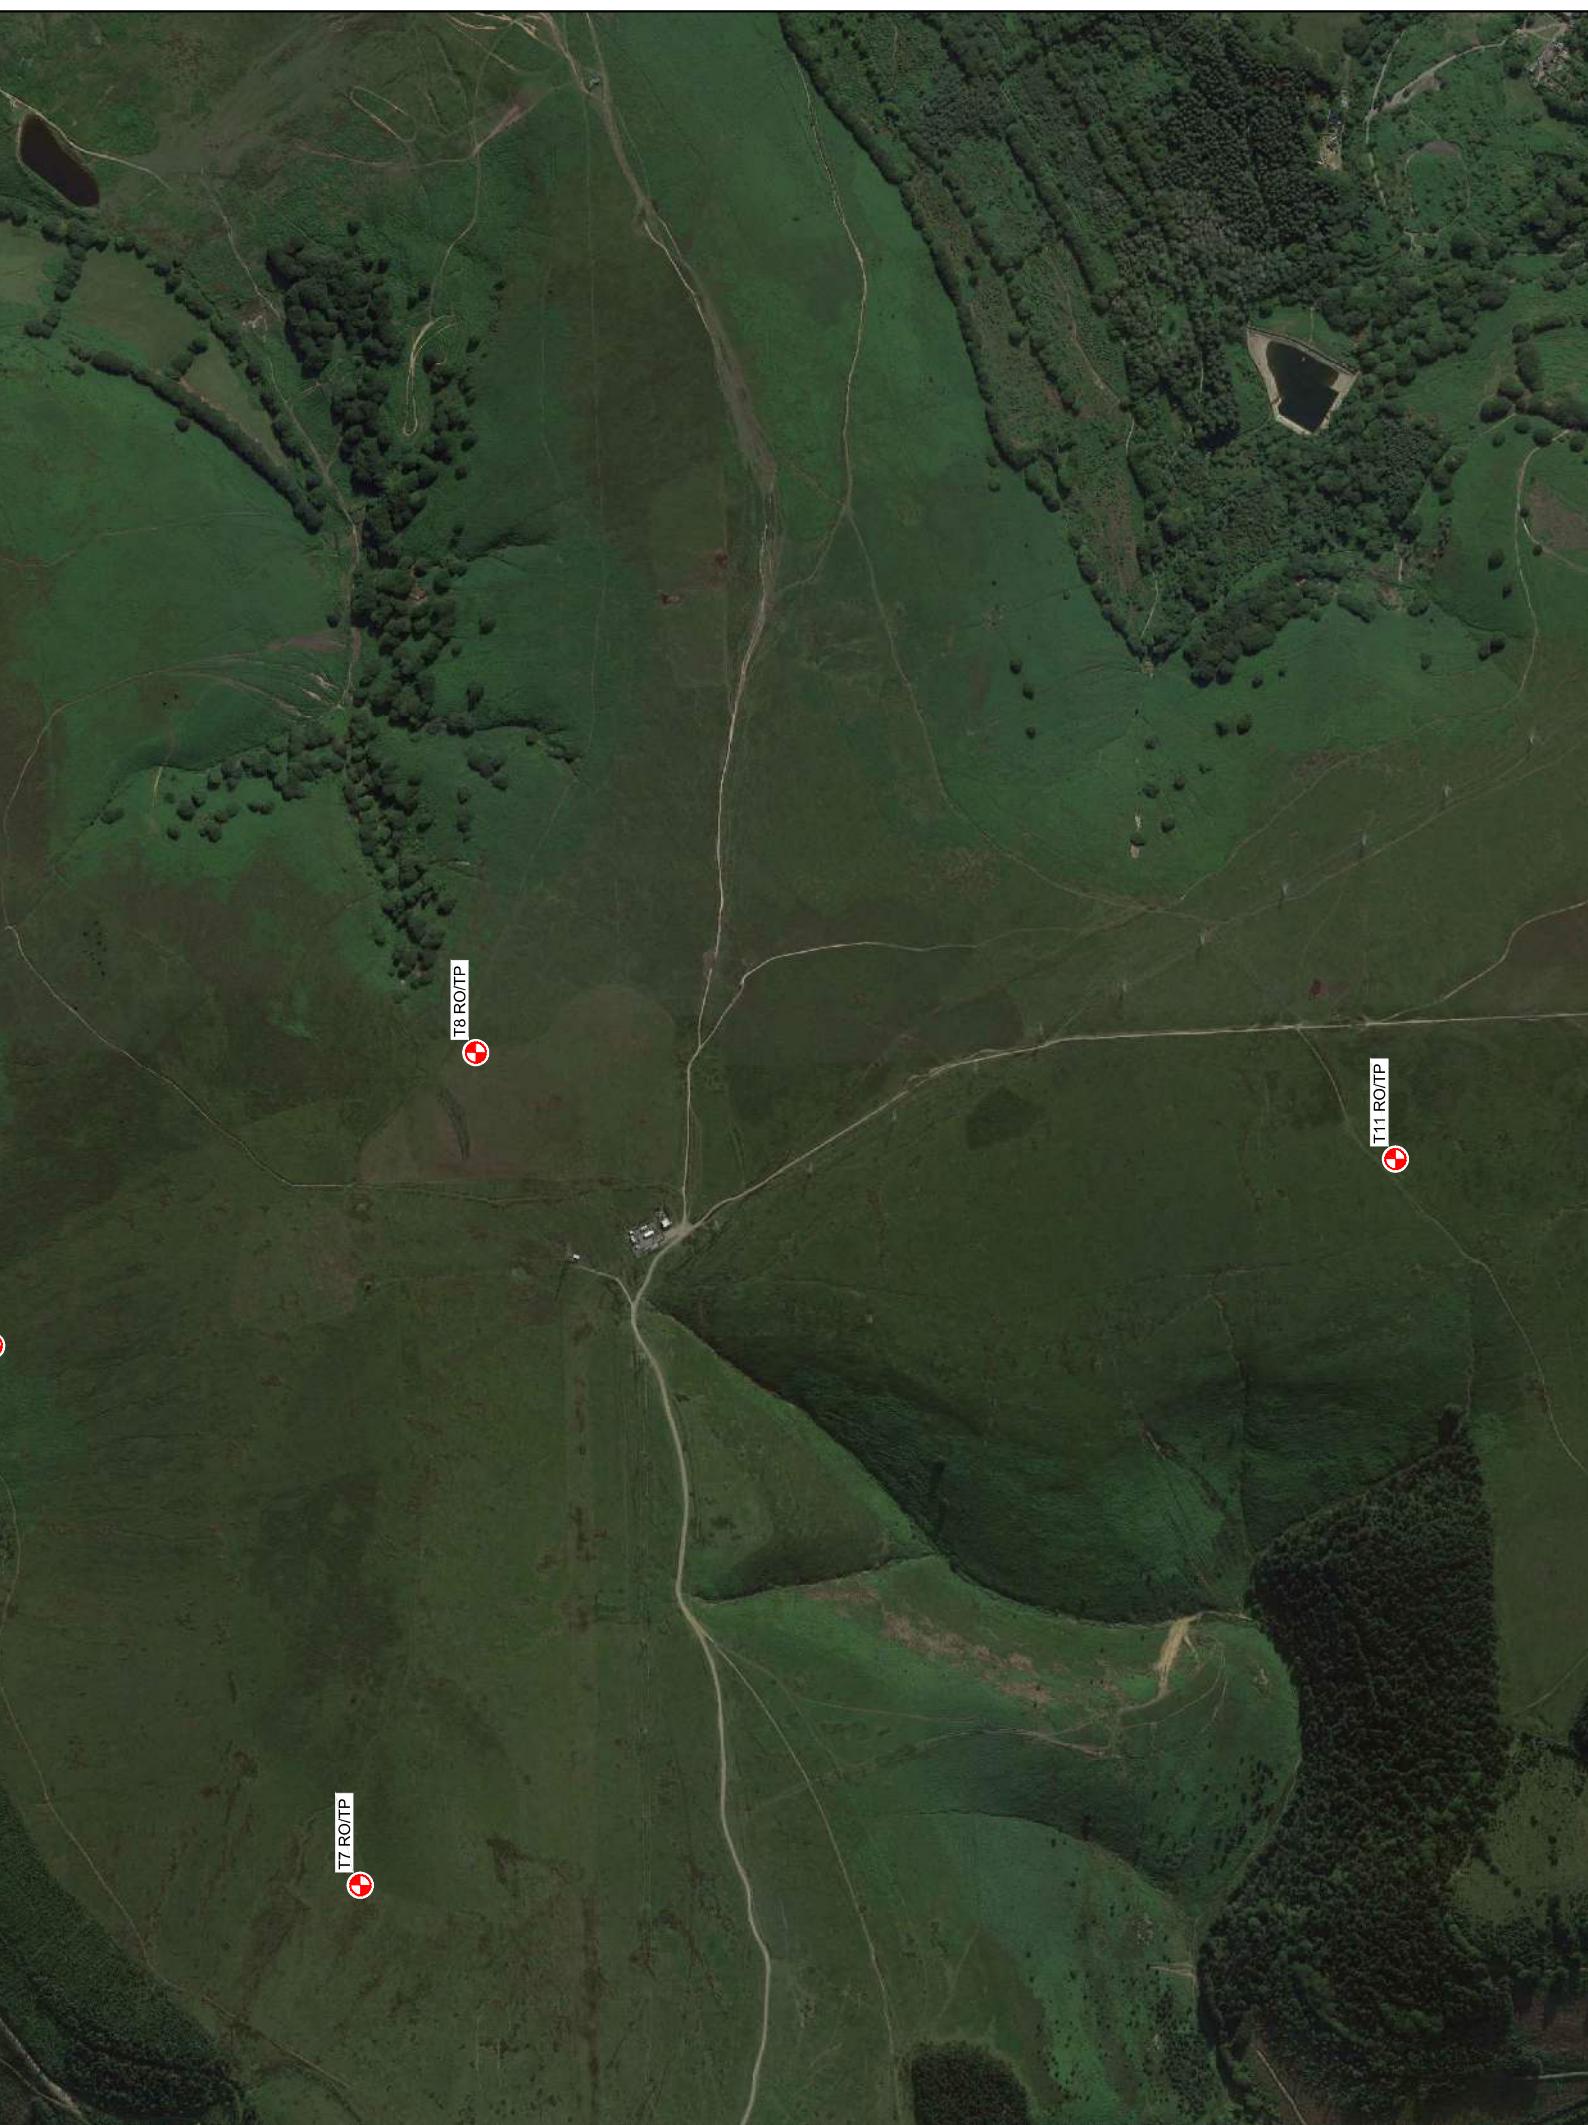
## FIGURE 3 EXPLORATORY HOLE LOCATION PLAN

Details of the investigation locations and rationale are presented in Table 4. Machine excavated trial pits were dug at each of the four proposed turbine locations (T3, T7, T8 and T11) to a maximum depth of 2.50m bgl before being backfilled with arisings. Four rotary open holes were drilled at each of the four turbine locations to a maximum depth of 20m bgl before being backfilled with bentonite. An exploratory hole location plan is shown on **Figure 3**.
